U.S. NAVY UNDERWATER SOUND LABORATORY  
FORT TRUMBULL, NEW LONDON, CONNECTICUT

6 TESTS OF A COATING APPLIED TO A DOME WITH  
SMOOTH FILLETS AT THE WINDOW AND TRUSS  
CONNECTIONS.

USL Technical Memorandum No. 933-385-64

This memorandum reports on the high-power transmission tests that were conducted to obtain information on what additional service might be gained from a dome coating if the voids between the trusses and the skin of the AN/SQS-26 dome are filled with a smoothing compound. The dome section that was tested was prepared by the U. S. Naval Applied Science Laboratory and is identified as USL Specimen No. 82.

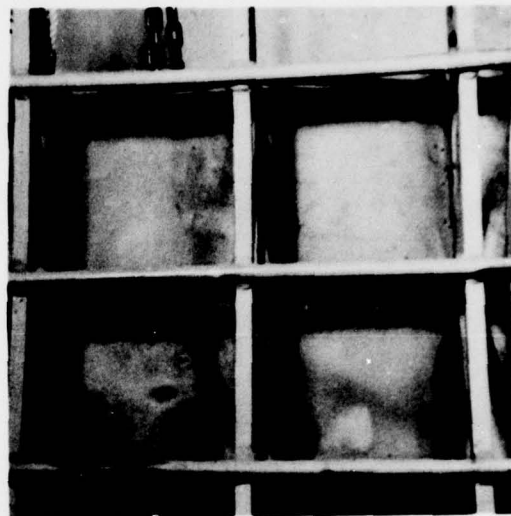
Fig. 2

The epoxy system consisted of 1 coat of Devco and Reynolds Co. Devran coating applied to the sandblasted metal surfaces, followed by 1 coat of Devran 204 coating and 2 coats of 121 vinyl red antifouling paint. The outside of the dome section is shown in Figure 2; the transducer side of area "C" is shown in Figure 3; the unfilled voids between the trusses and the skin of the dome are shown in Figure 4; and the filled voids are shown in Figure 5.
